*Fig 1: Davis Welded Mesh Sheet showing the lath initial state as a sheet,
in an unrolled state.*

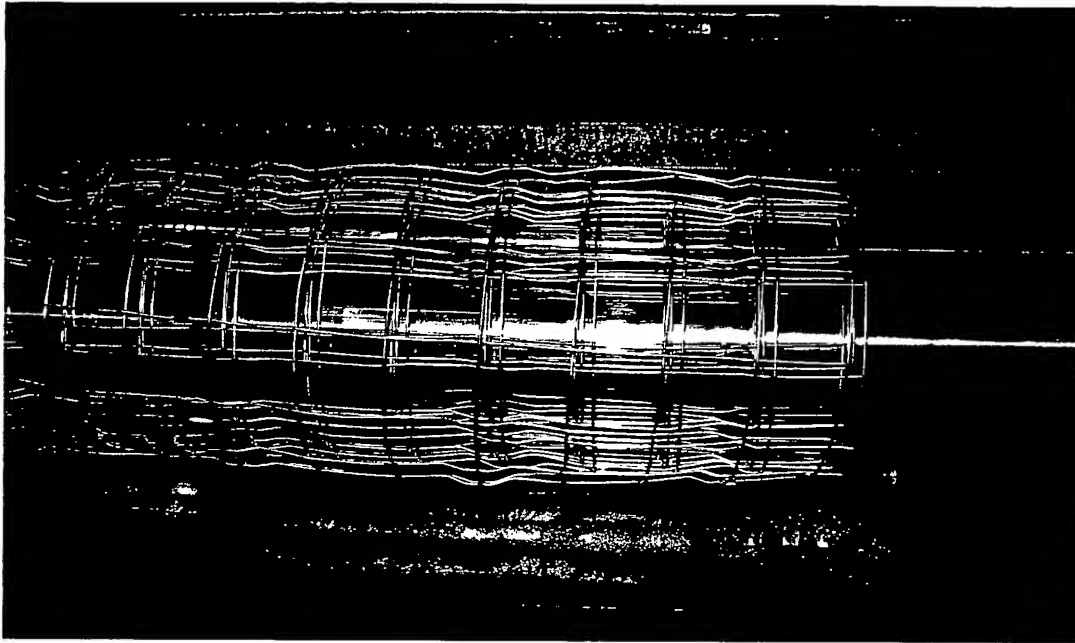
Fig 3: Davis Welded Sample on Coiler Mandrel.

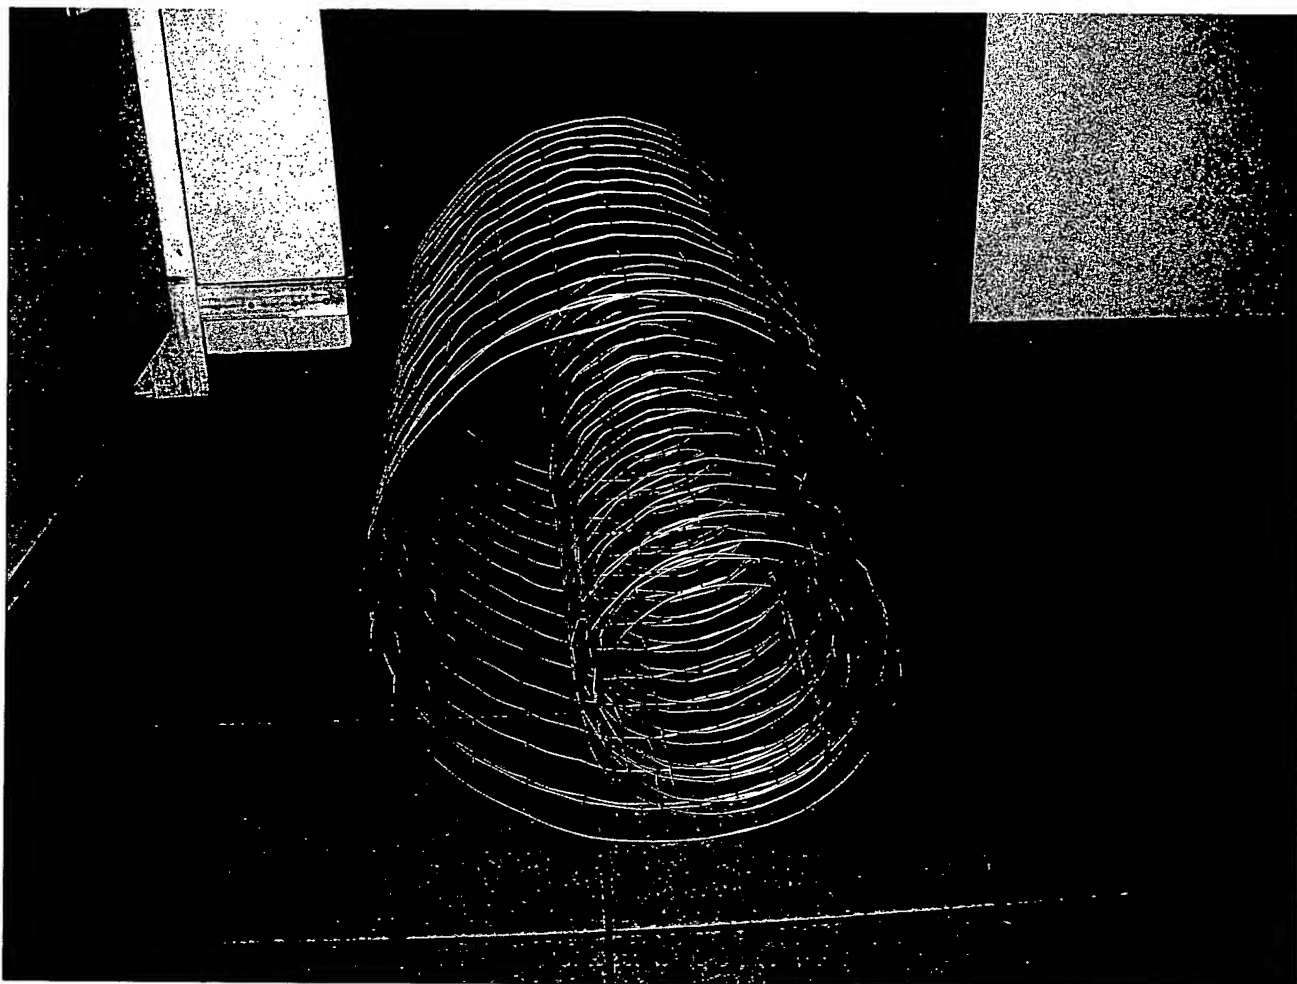
Fig 4: Davis Wire remains coiled after being rolled.

*The lath has acquired a curvature and must
be forcefully unrolled to reacquire a flat shape.*

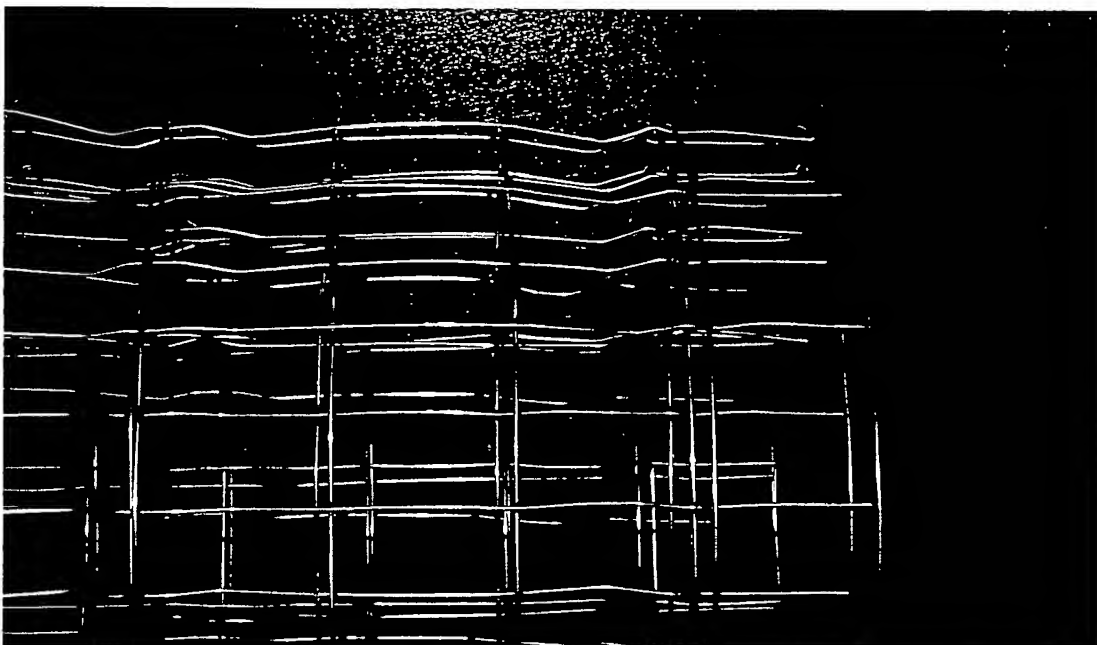
*Fig 5: Shape of Davis Cross Wires After Being Rolled.
The curvature of the wires is approximately the same depth
as the furrs themselves, thus rendering the furrs ineffective.*

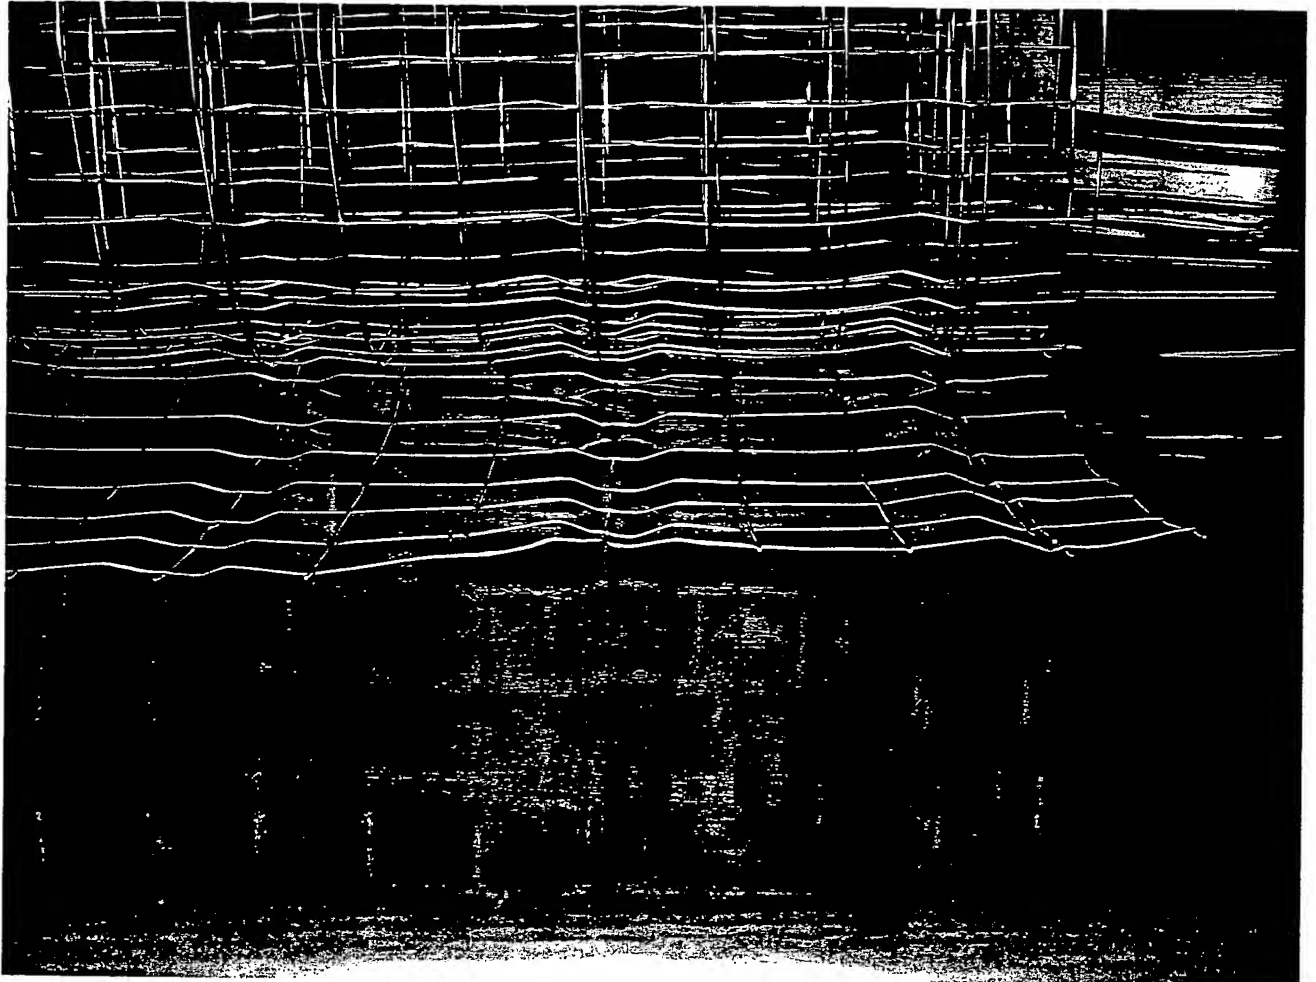
*Fig 6: Shape of Davis Wire Cross Wires After Being Forcefully Unrolled.
The furring structure is obliterated and the wires are crooked.*

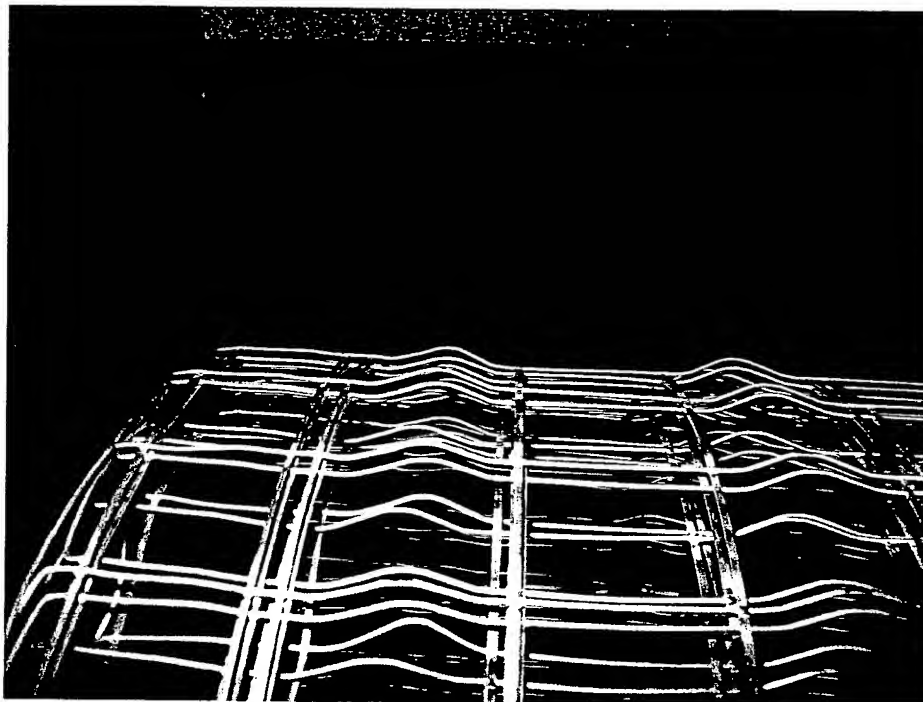
Fig 7: Shape of Structa Wire Cross Wires on Coil at the Beginning of Test.

(Structa Lath is shipped in Rolls not in Sheet.)
